INTERSTATE COMMERCE COMMISSION
WASHINGTON

REPORT OF THE DIRECTOR
BUREAU OF SAFETY

ACCIDENT ON THE
BOSTON AND MAINE RAILROAD

SEPTEMBER 10, 1939

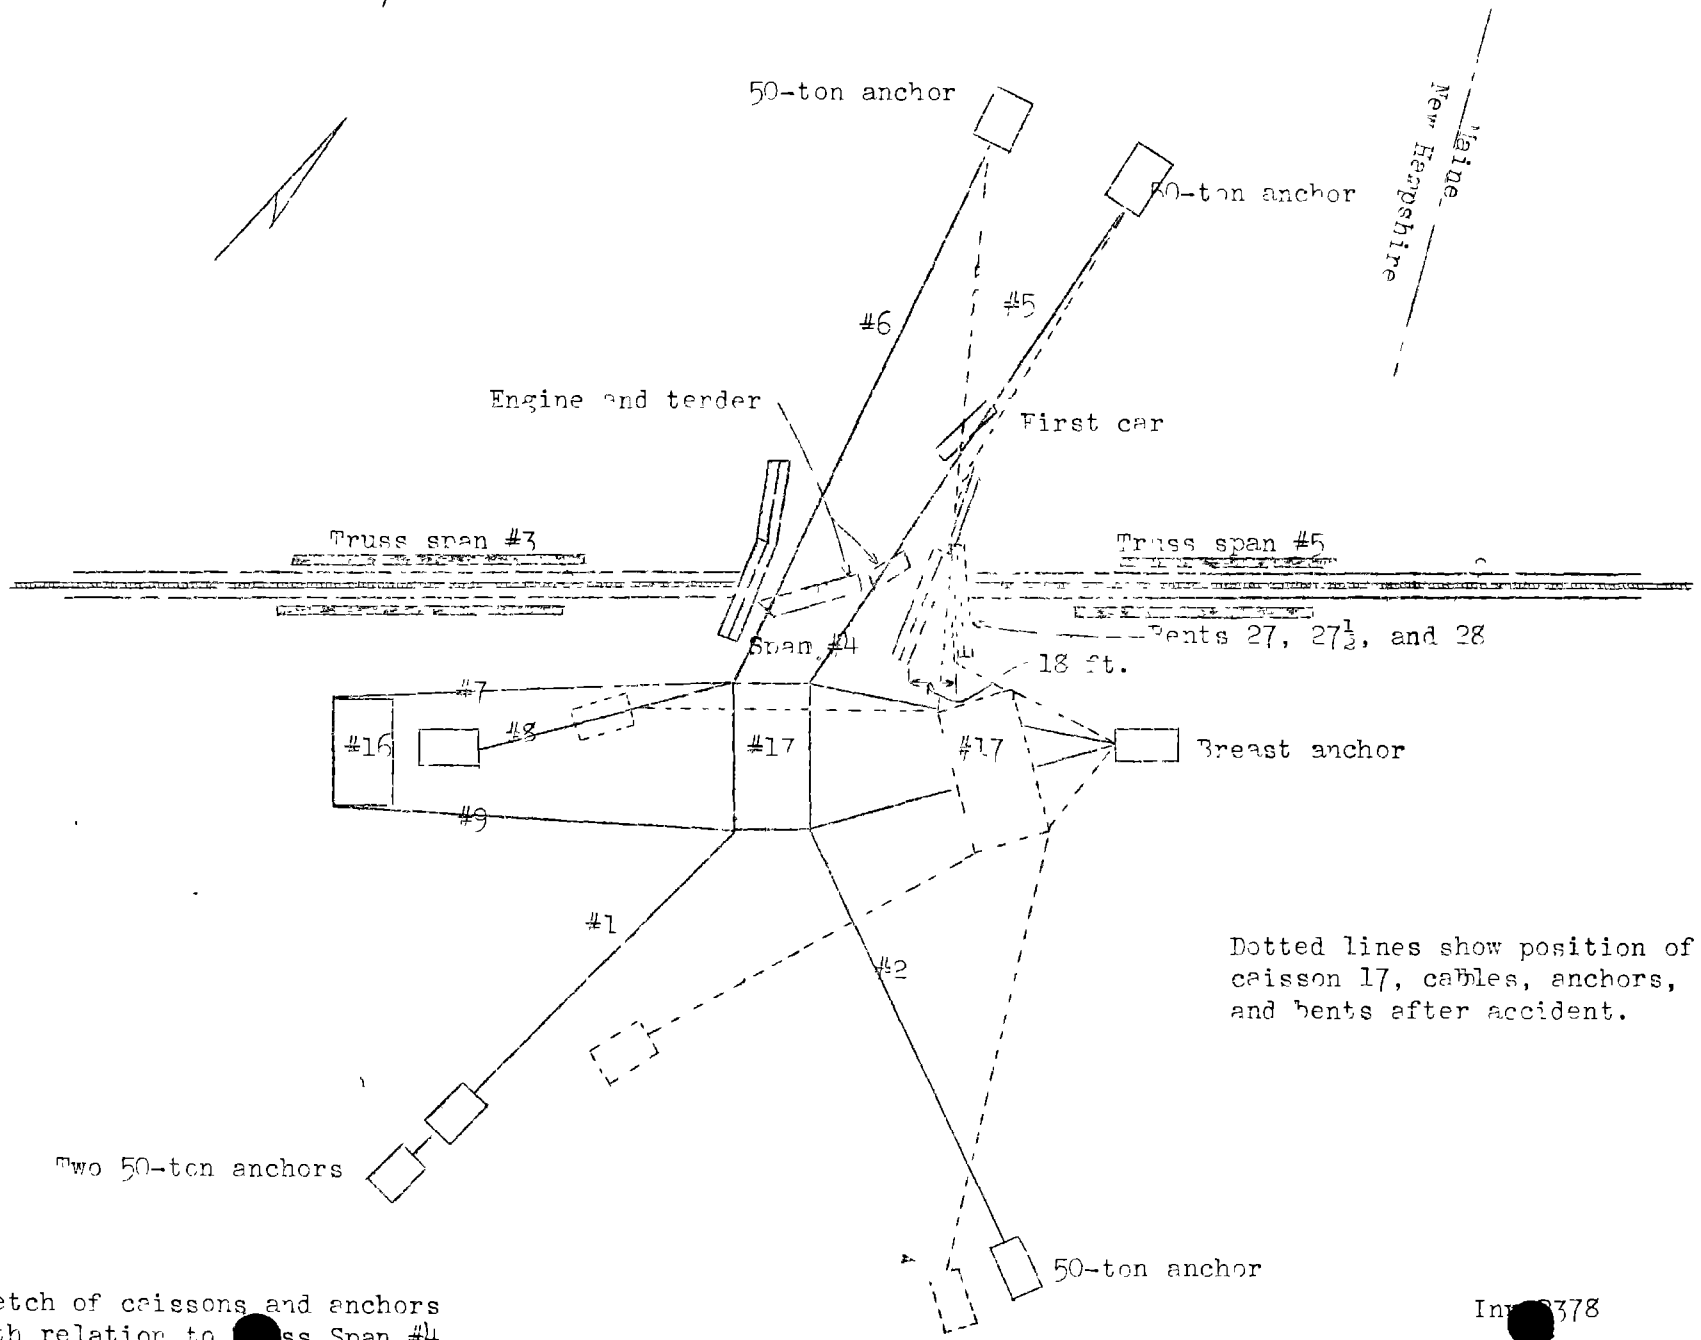
Sketch of caissons and anchors with relation to Truss Span #4

After the accident it was found that caisson 17, located downstream from the railroad bridge and weighing approximately 4,200 tons, had drifted eastward a distance of 88 feet, and that the cables leading from the caisson to its upstream anchors had fouled the piles of bent 27, finally pulling that bent, together with bents 27-1/2 and 28, eastward a distance of 18 feet at the downstream end; no material bending took place at the upstream end. Although occasional signs of rot were discovered at the span involved, it was not sufficient to have contributed to the cause of the accident. Examination of the downstream truss after its recovery from the water did not indicate that it failed because of structural weakness of any kind. If the caisson and the upstream cables had been in their proper positions when the engine and the span dropped into the water, the engine would have fallen on cable 5 and in all probability it would have broken or pinned down the cable. The first car was found 100 feet upstream and resting on cable 6, which extended from the caisson toward the west upstream anchor. These cables extended upward from their anchors to the caisson, being attached 46 feet above the cutting edge of the caisson, and it is believed that it would have been impossible for this car to be on top of the cable unless the caisson first had dragged its anchors and drifted eastward to the point where it was found after the accident. It is to be noted further that, under one portion of the downstream truss, one of the divers found a cable which was slack and which led in the direction of caisson 17; he could not follow it in the opposite direction as it was embedded in the streambed; it is probable that it was cable 8 leading to the west breast anchor.

protection against this cross-stream current, because of the angle at which it was anchored on account of interference of the piles of the railroad bridge, and the holding power in that direction was in the downstream west anchors, the cables around caisson 16, and the west breast anchor. It is believed that the weather and the tide conditions prevailing at the time caused caisson 17 to drift, placing heavy strain on cables 7, 8, and 9, and cables 7 and 9 broke, shifting the strain to cable 1; then the connection to one of the 50-ton anchors snapped off, and caisson 17 drifted eastward, dragging the other 50-ton anchor and the breast anchor. Caisson 17 continued to drift until it became grounded after the upstream cables had caused sufficient damage to the bridge to permit truss span 4 to be unsupported at its downstream corner, and the span collapsed when the weight of the engine hauling No. 2020 was placed upon it.
